# Walk Around

## Focke-Wulf Fw 190A/F

Walk Around Number 22  
squadron/signal publications

By Malcolm Laing and E. Brown Ryle

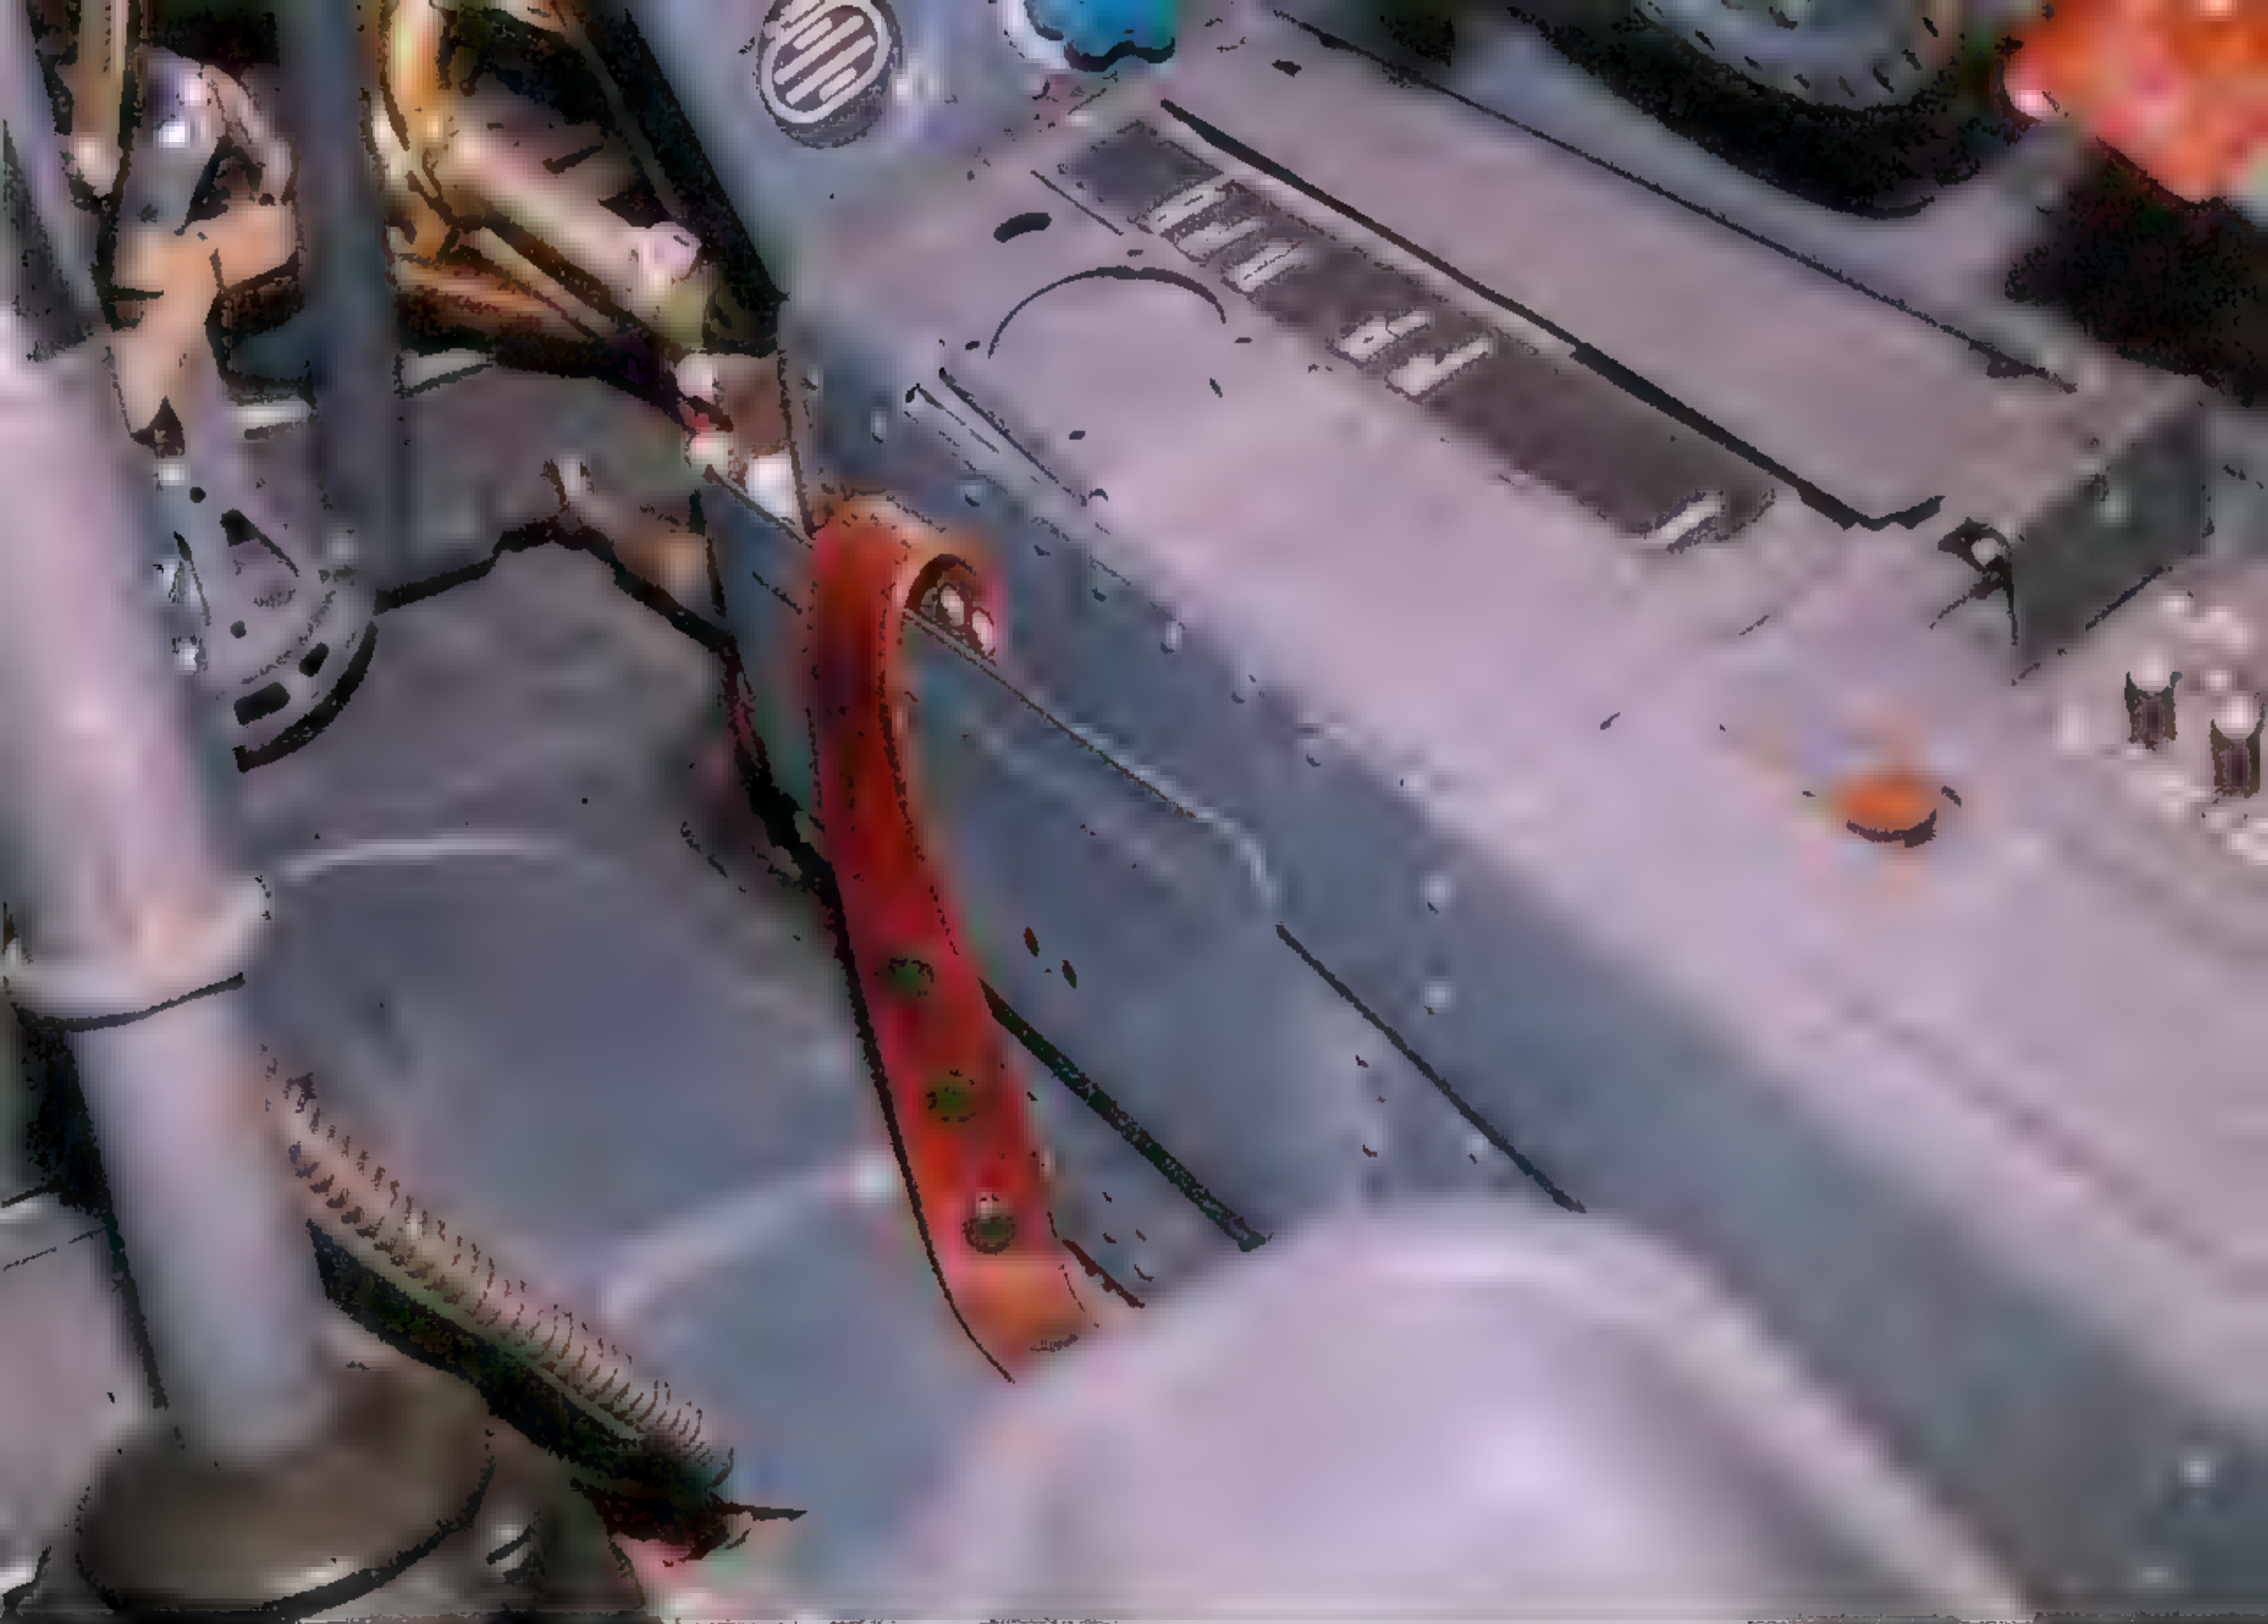
The map case and its leather strap are alongside the starboard console of the Fw 190F-8 cockpit. This position allowed ease of pilot access to maps during a flight. The control stick has a rubber boot (dust cover) over its base. German fighter aircraft cockpits were normally painted RLM 66 Black Gray (FS36081). (Ryle)

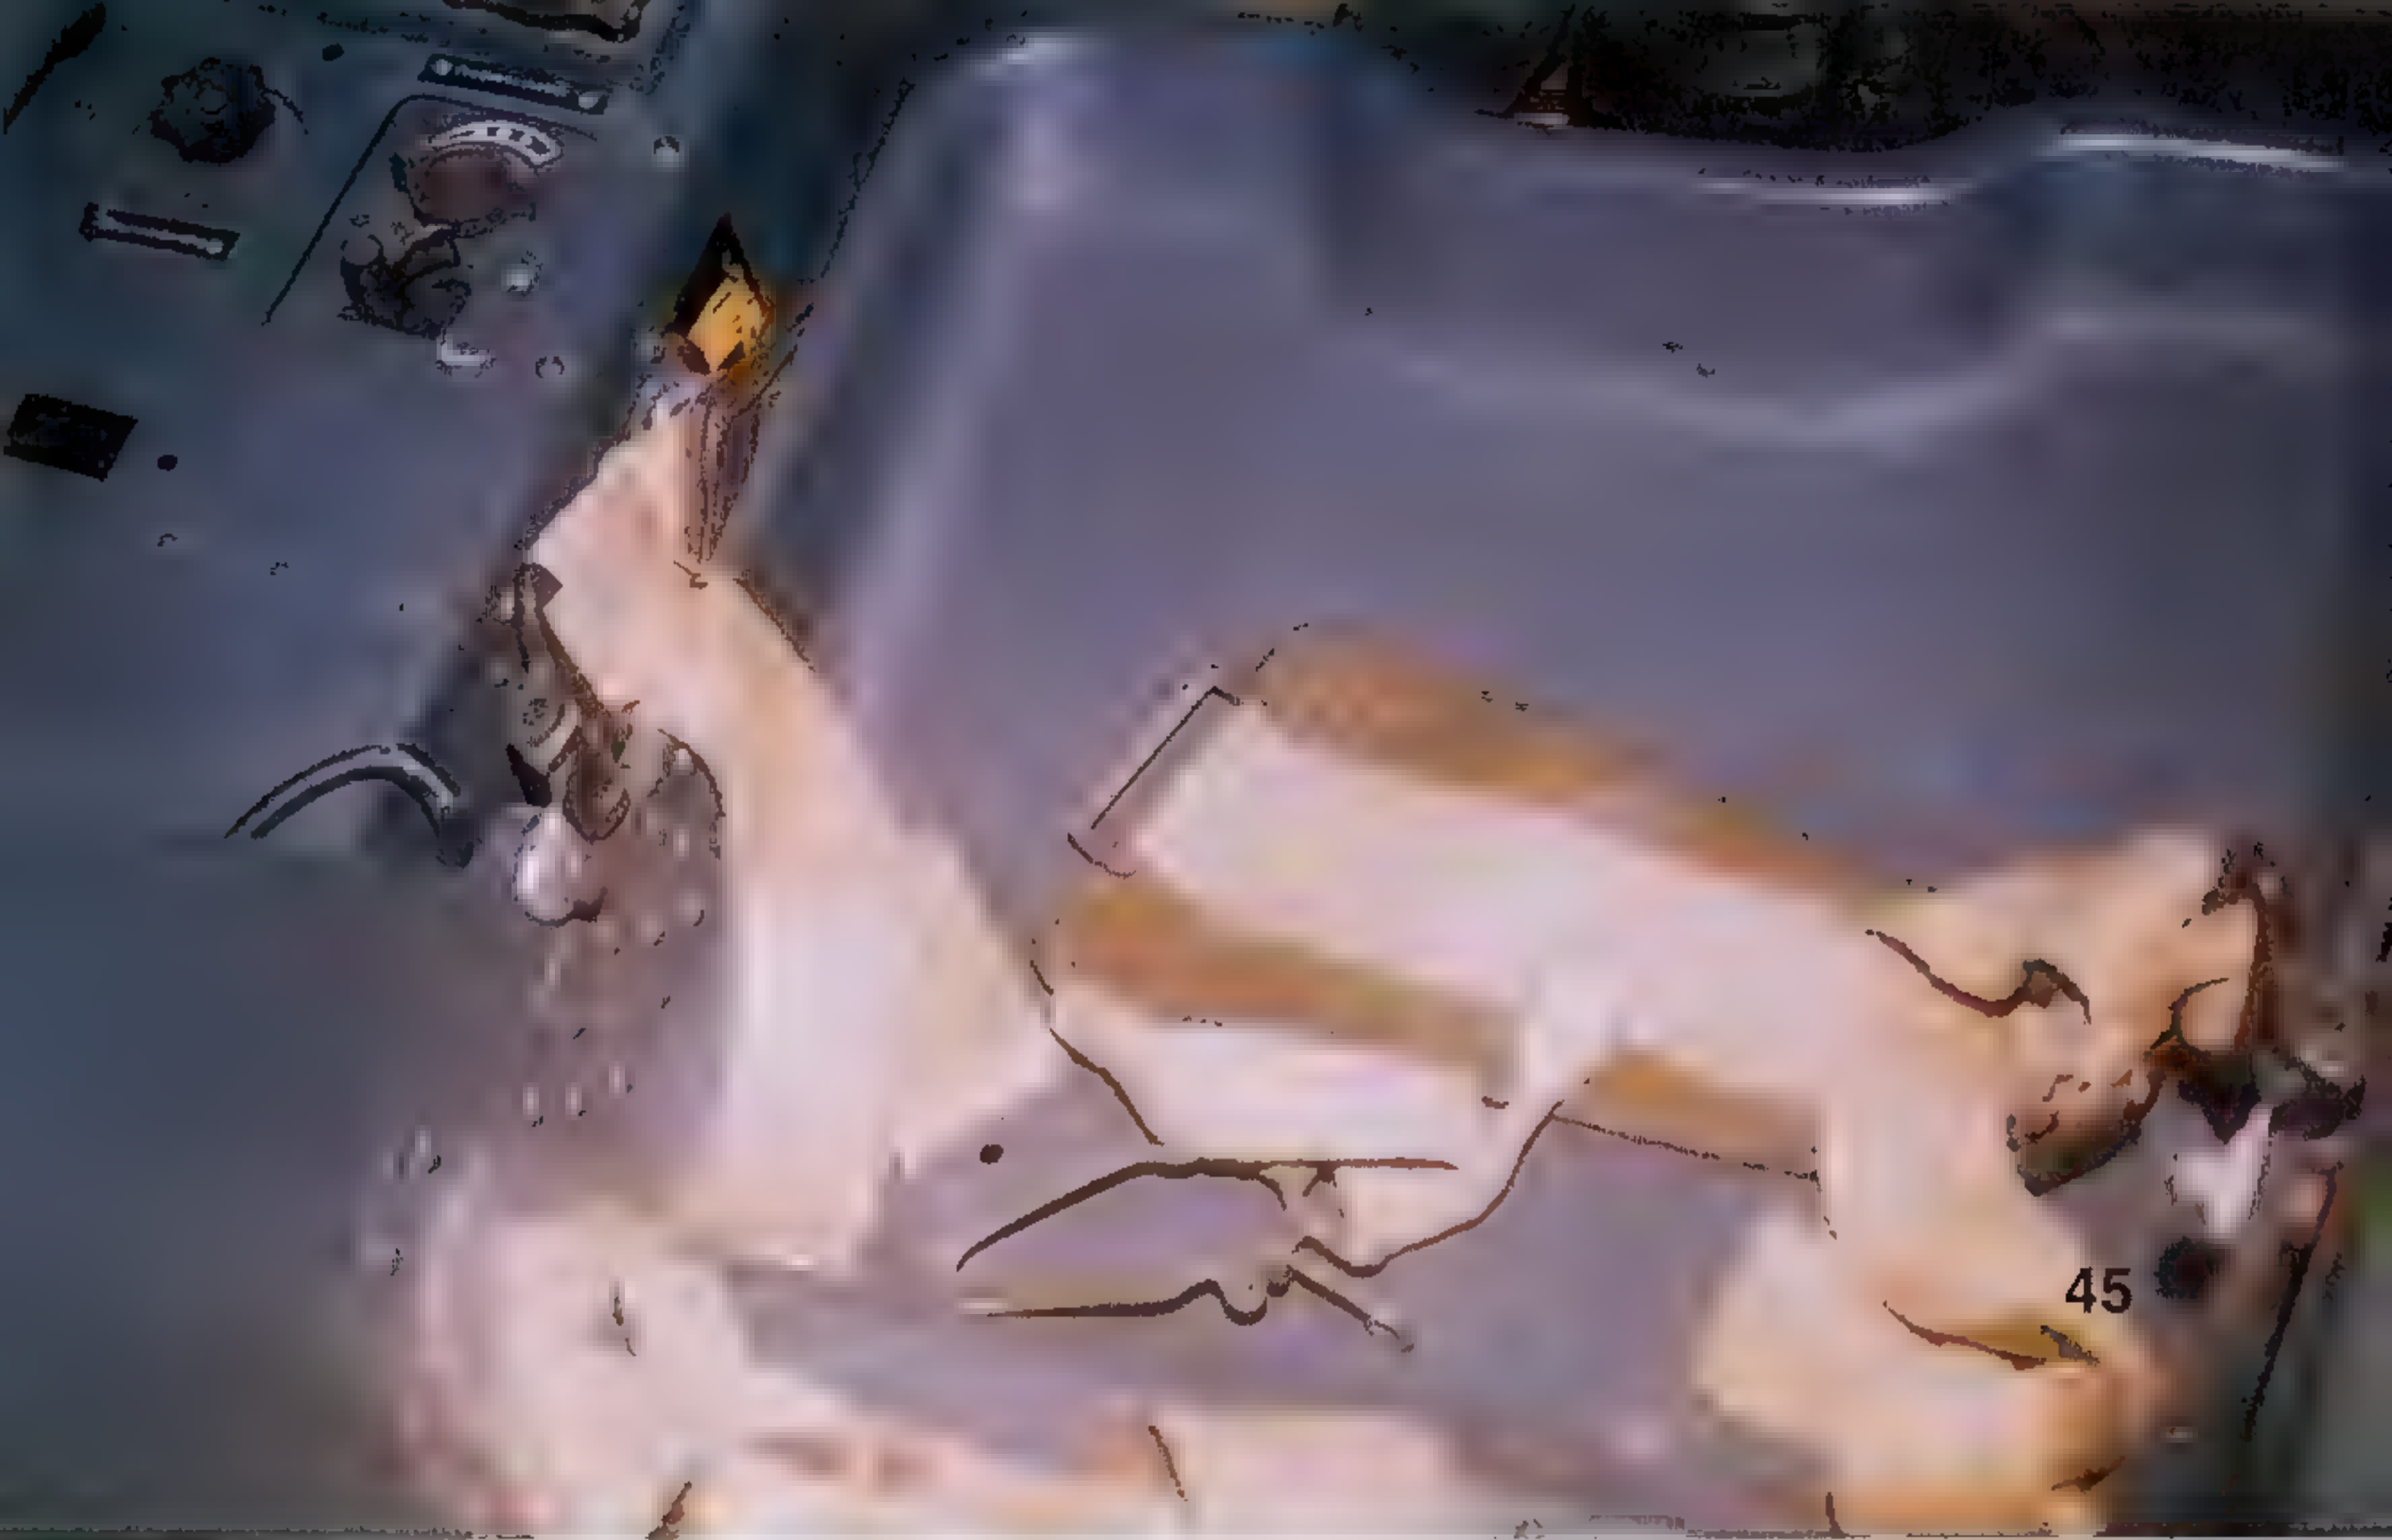
The Fw 190F-8 pilot's seat and lap belts remained generally the same throughout the Fw 190's service. Each lap belt was equipped with a thick, triangular chafing pad. The aluminum seat pan – the lower portion of the seat – was riveted to the 8MM armored seat back plate. This pan usually had a seat cushion installed. The upper rear portion of the pan has a shelf for the pilot's parachute to rest on. (Ryle)

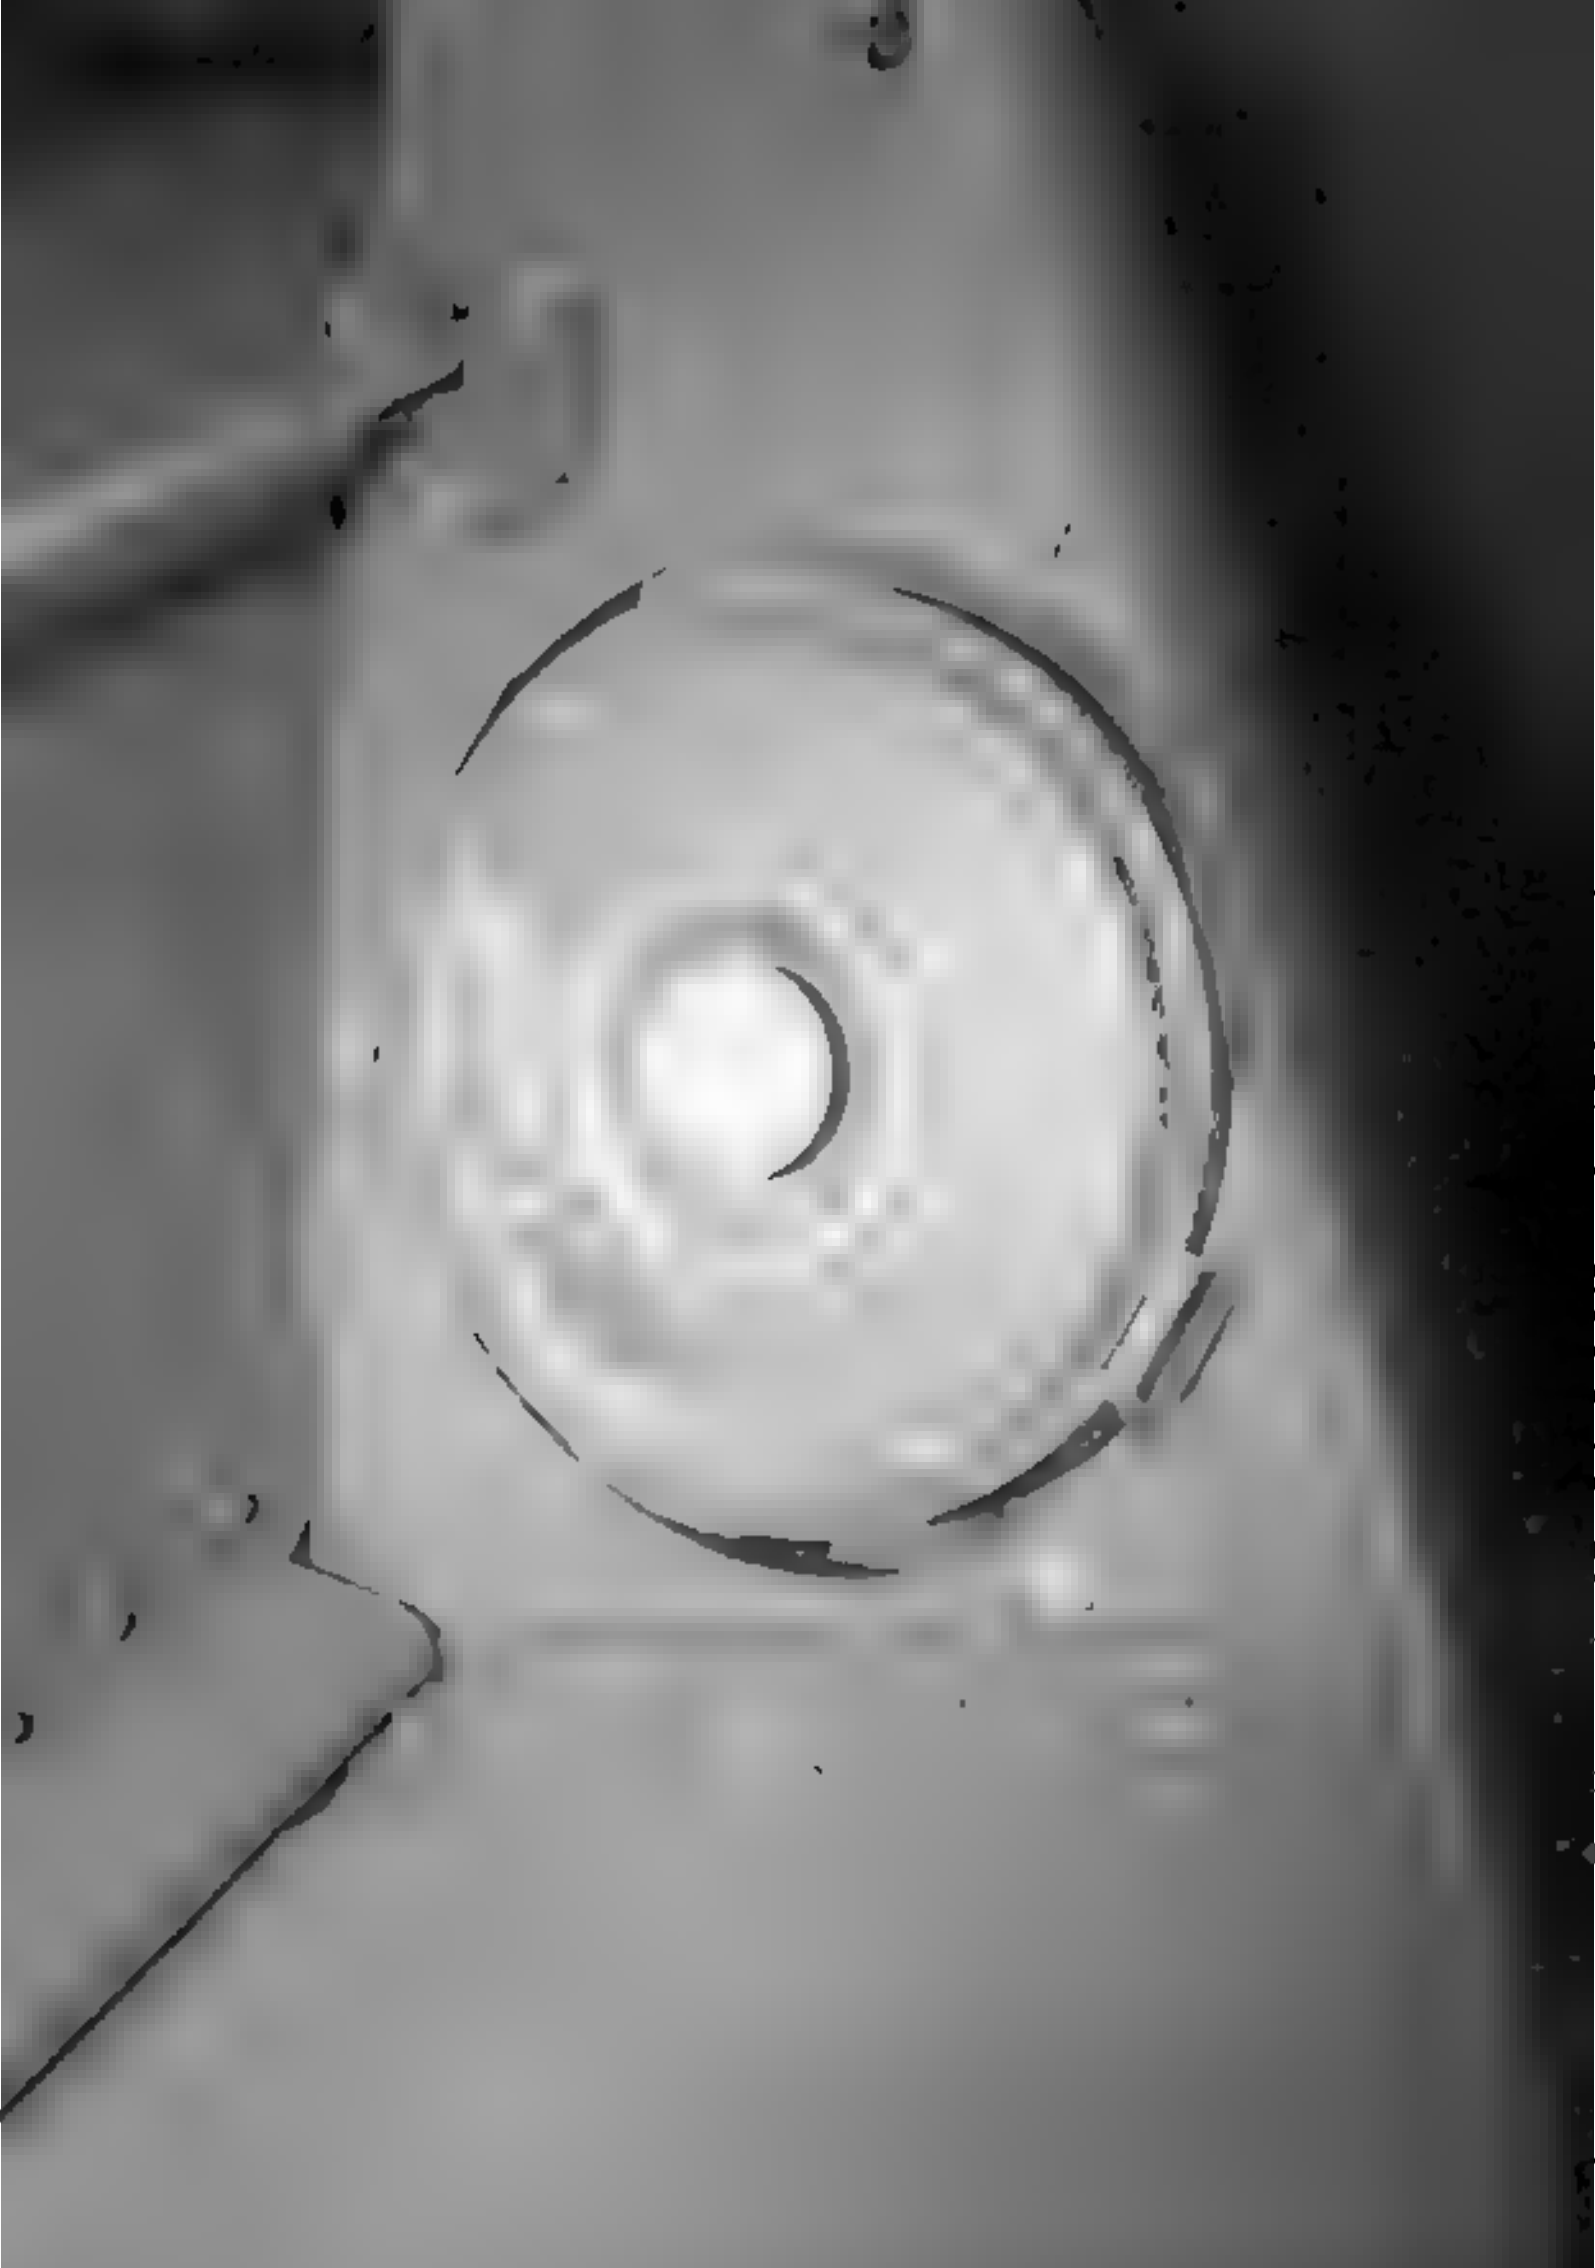
# Oxygen Regulator

(Left) The oxygen regulator unit is mounted on the aft starboard bulkhead of the Fw 190F-8 cockpit, with the canopy jettison rod above and to the left. When the oxygen valve is opened, oxygen comes from steel bottles mounted in the aft fuselage, to the regulator unit, and into the pilot's oxygen hose. The emergency pressure button on the center of the unit could be actuated by the pilot's right elbow (Ryle)

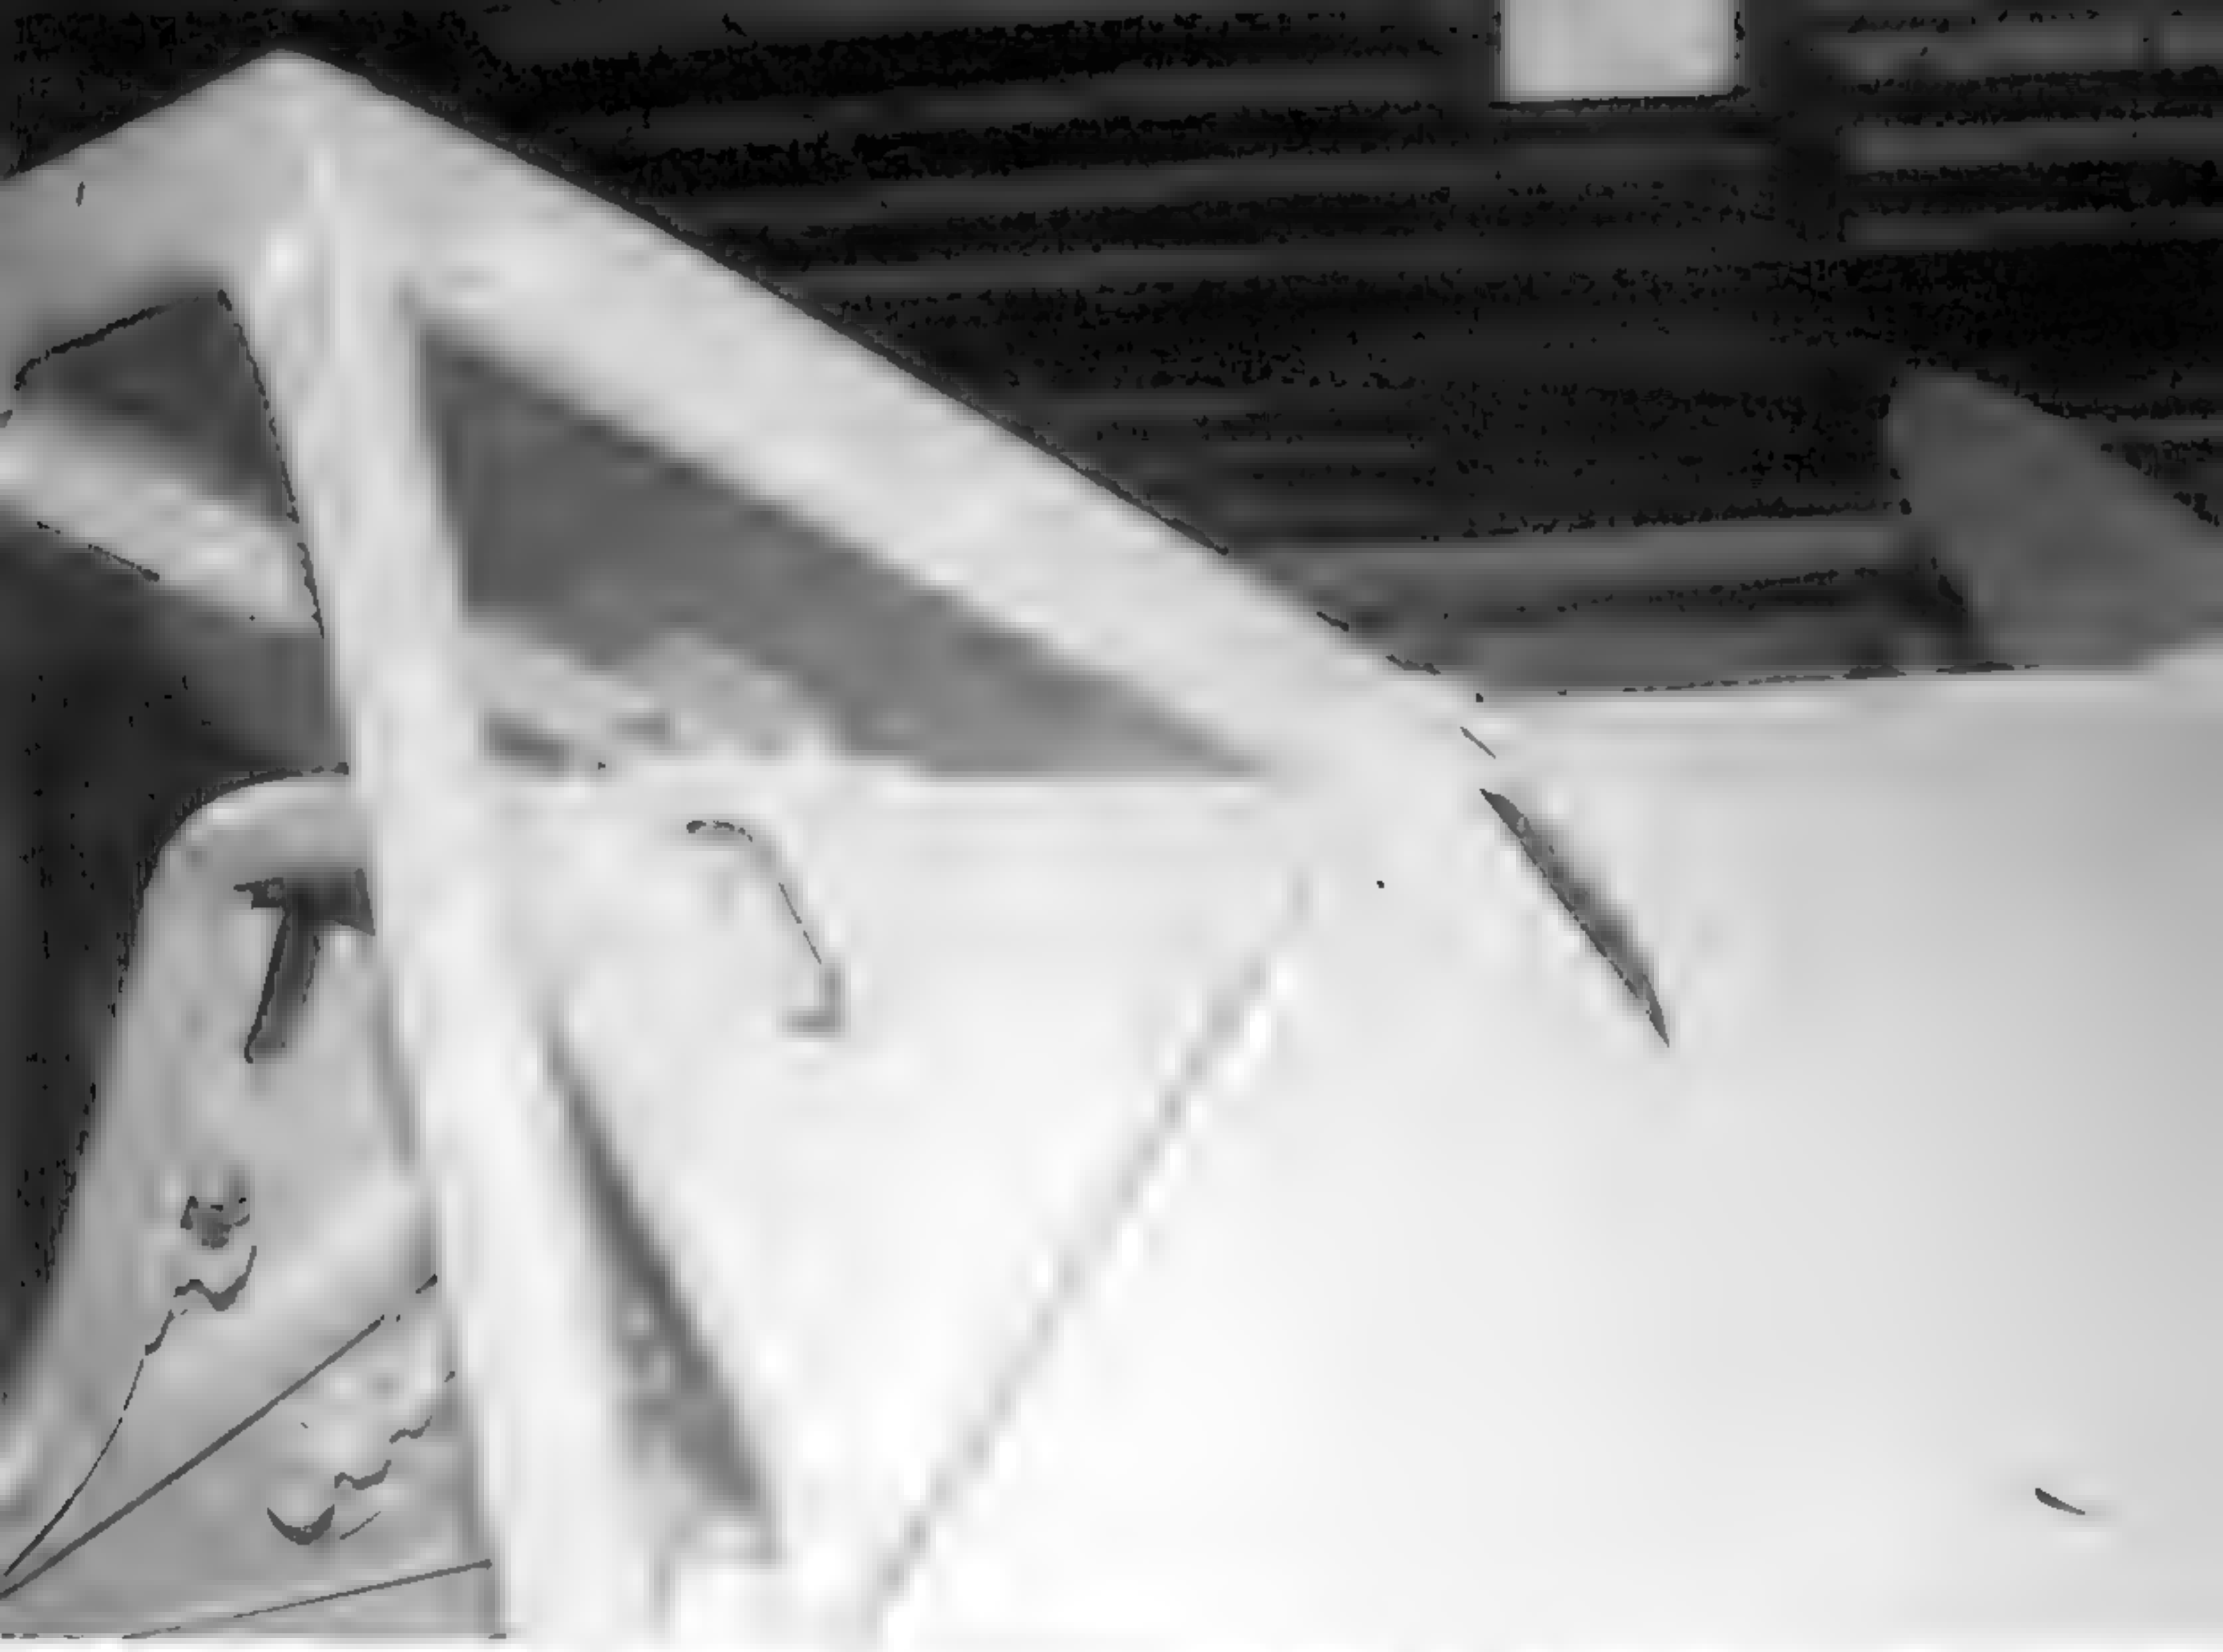
The Fw 190F-8's forward armored windshield is set at a 25° angle and is 50mm (2 inches) thick. All three panes are set in a steel windshield frame and secured with a screwed on molded framing. The hole for the canopy spike is fitted on the upper rear of the windshield framing. (Ryle)

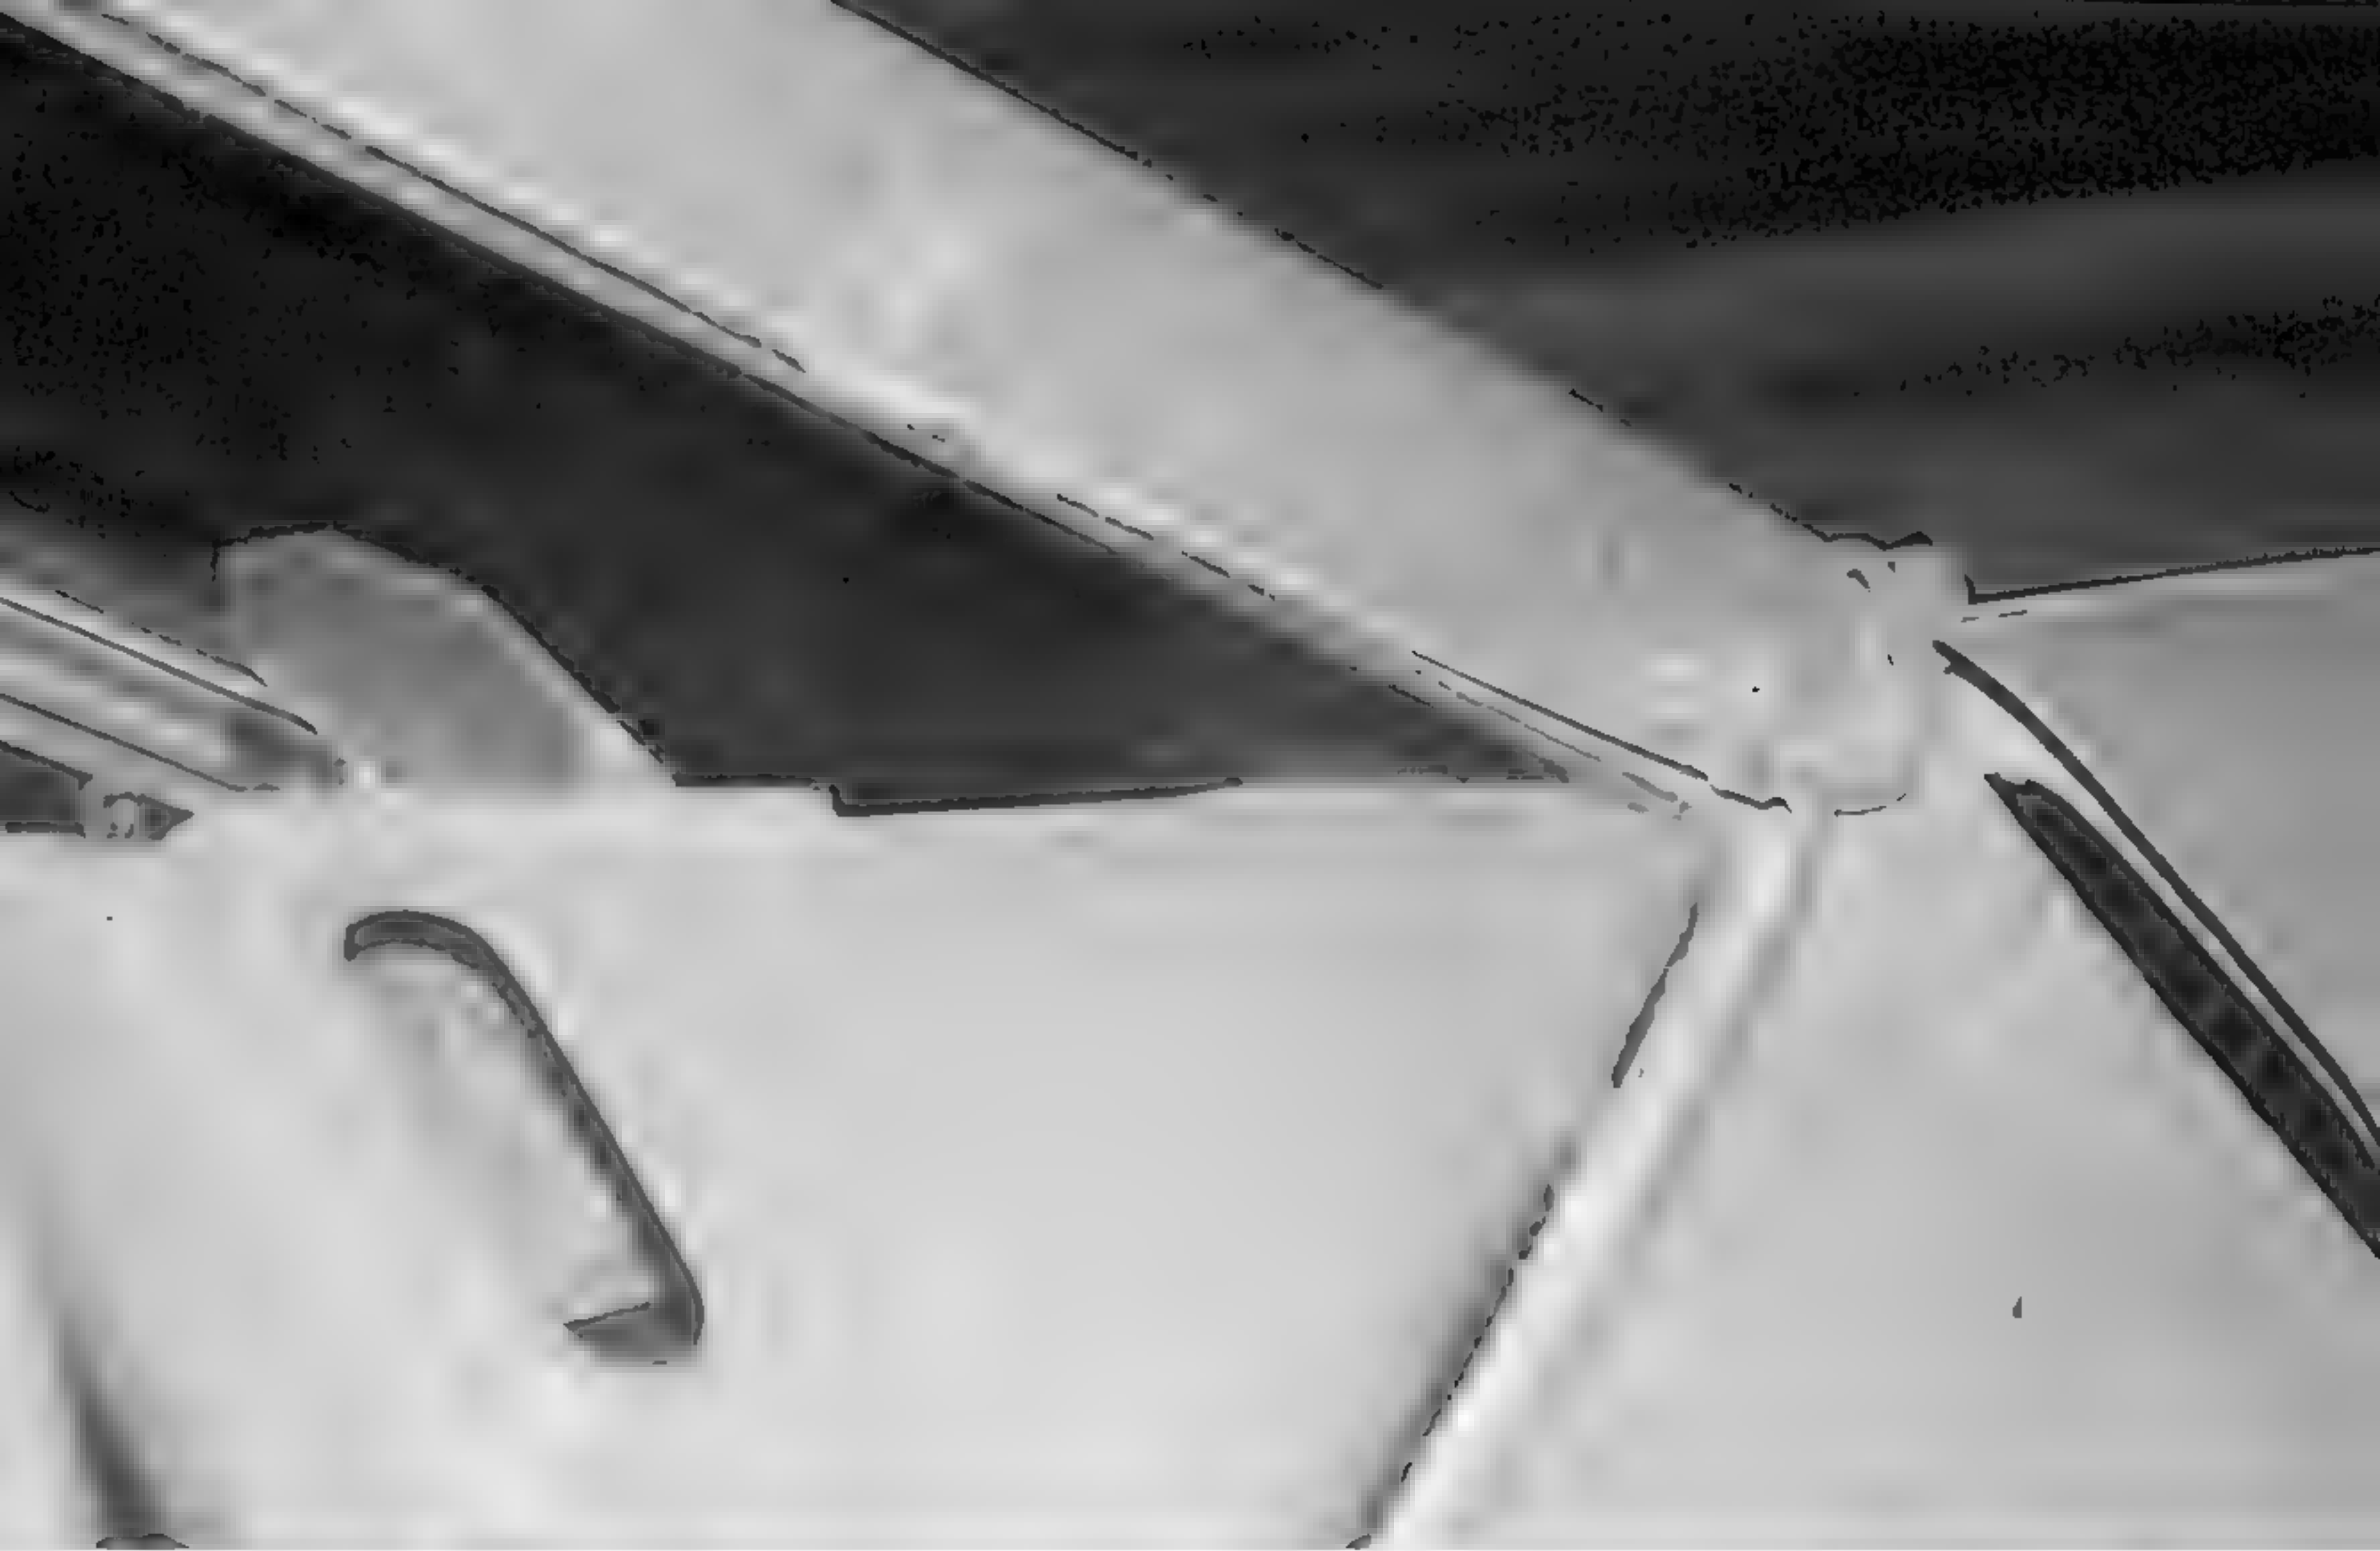
The piping for the Fw 190F-8's windshield deicing system was attached to the windshield by brackets secured with molded frame screws. The cooling/smoke vent for the two 13MM MG 131 machine guns is placed in the aft edge of the cowling gun cover. (Ryle)

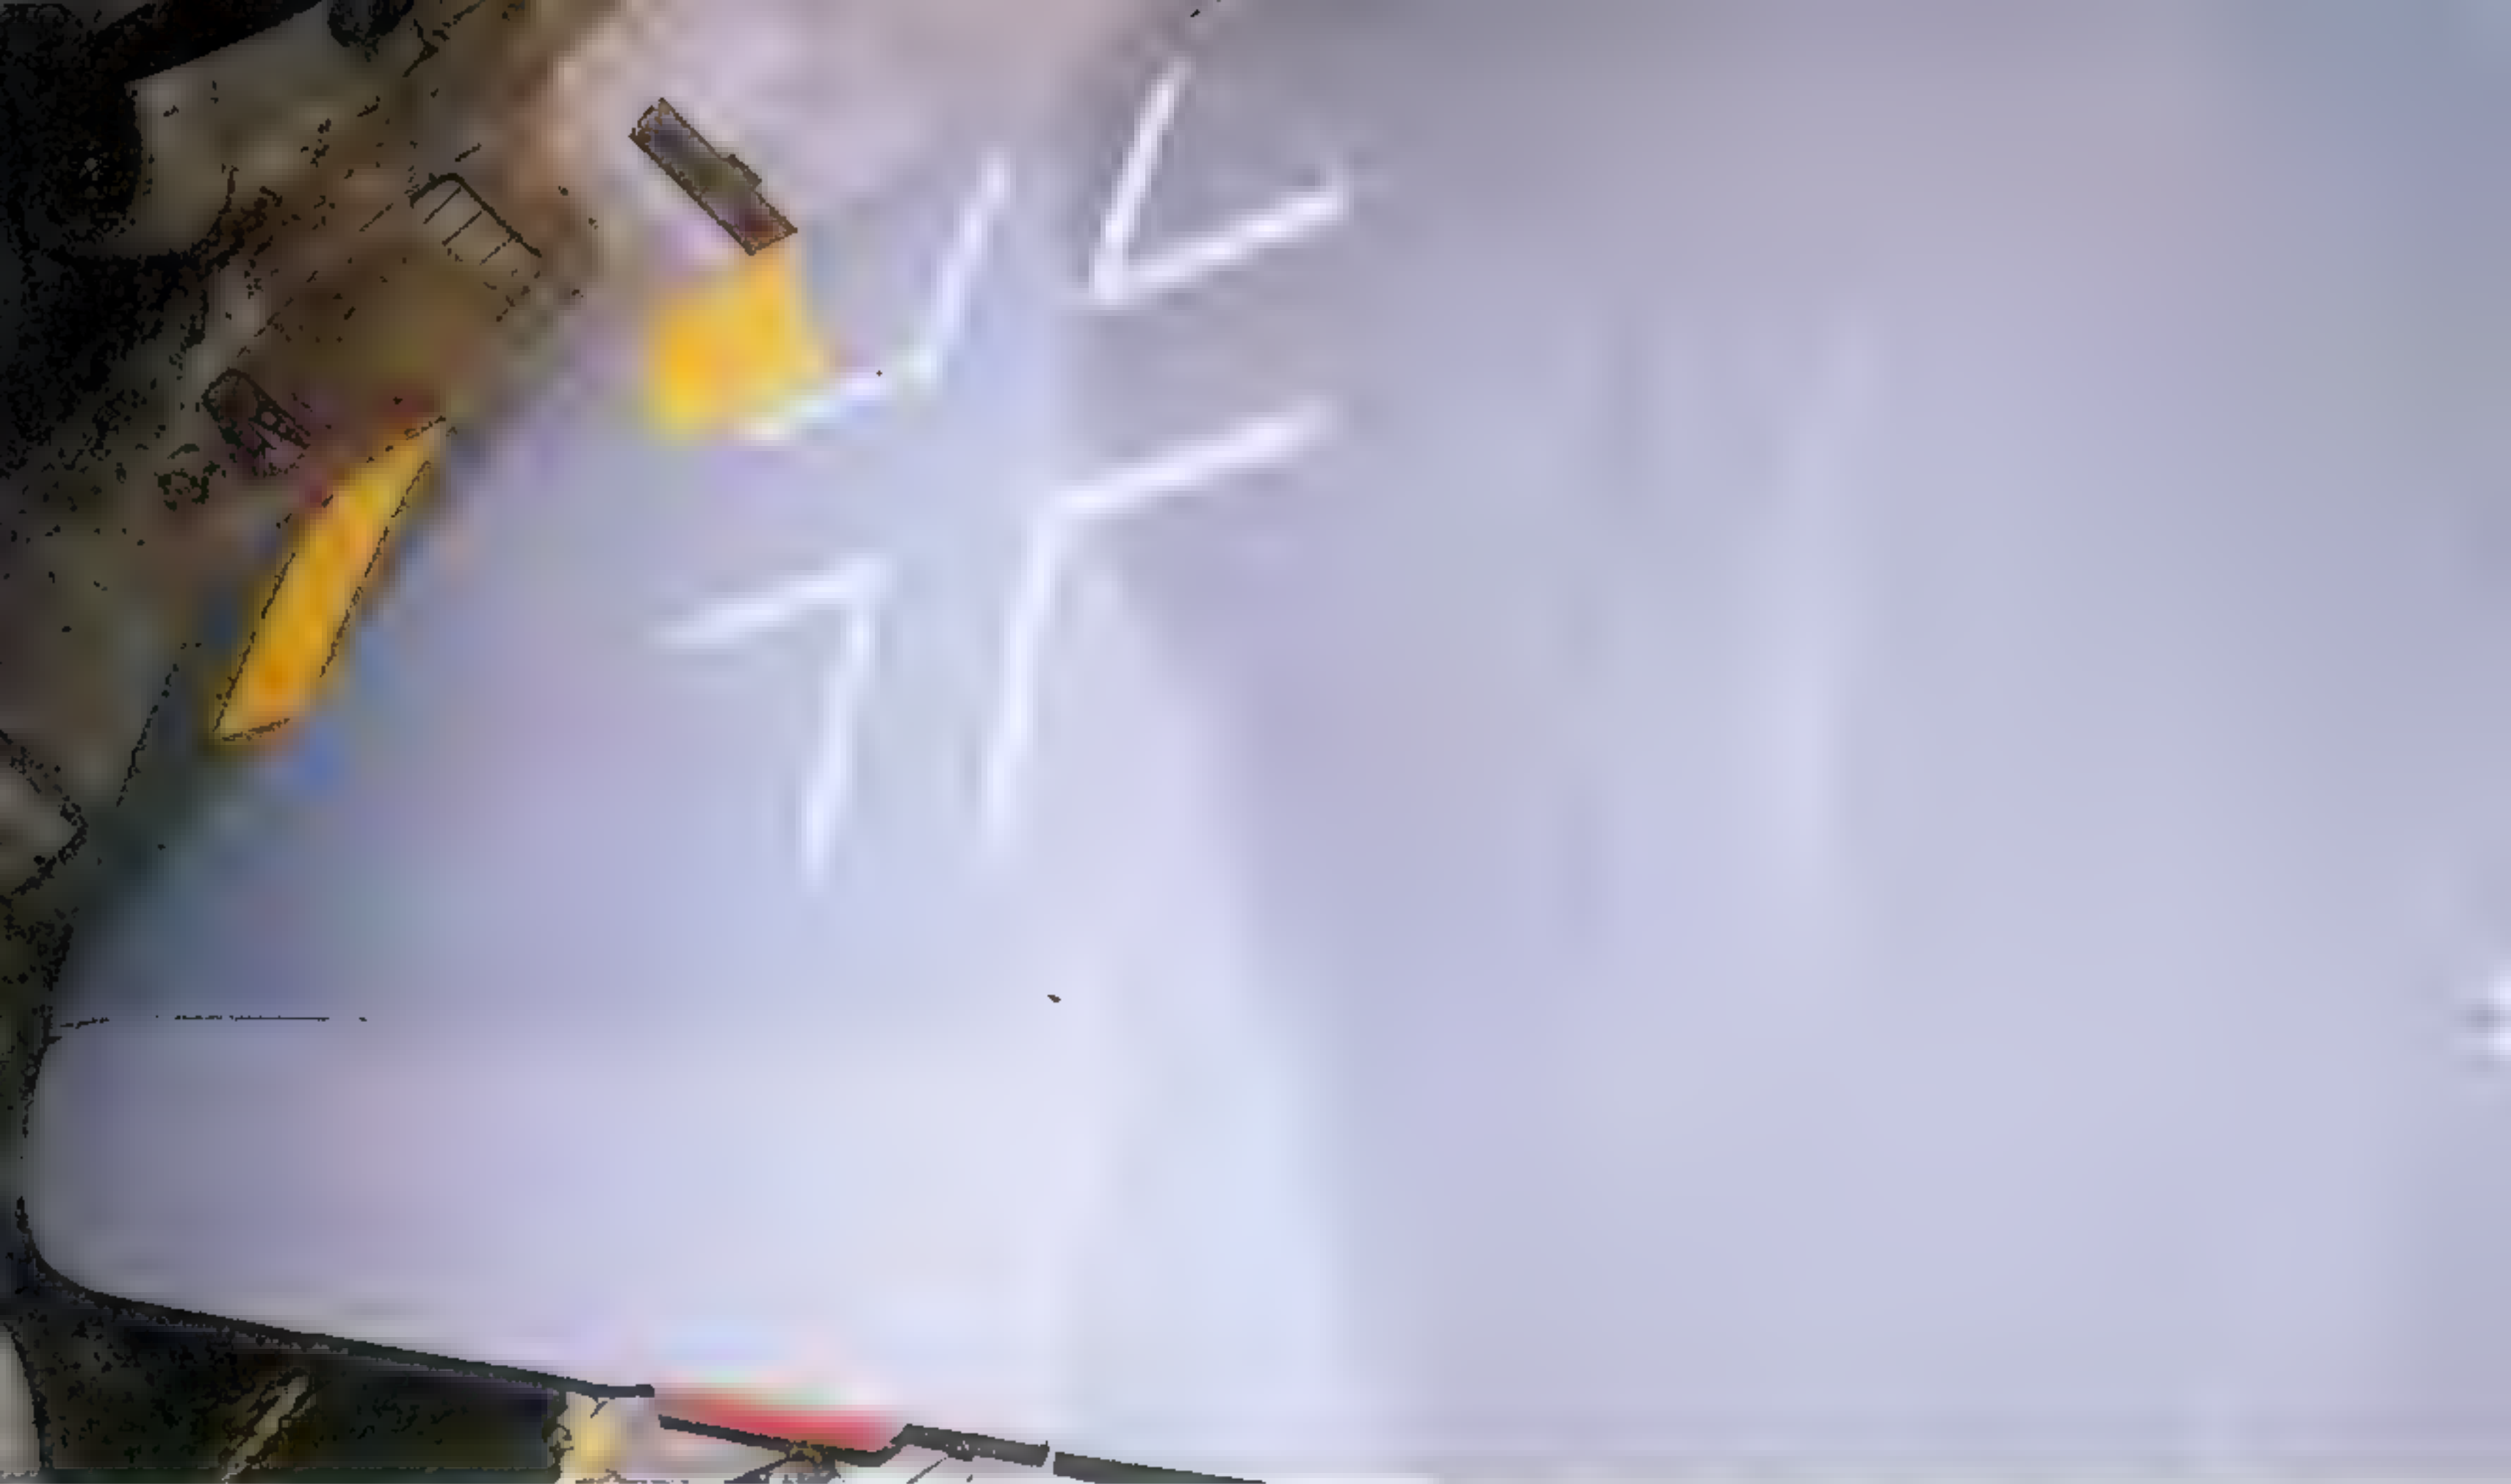
The Fw 190F-8 wing was almost identical to the A-8's, apart from the F-8's added gun; breech bulges. The NASM painted their F-8 in RLM 70 (Black Green)/75 (Gray Violet) after determining this was the color scheme applied when this Fw 190A-4 was rebuilt to F-8; standard. The yellow underwing chevron arms have overlapped onto the upper port wing. The two sets of broken lines on the inboard wing surface indicate the wing walk area. Further outboard is the fabric covered aileron and its ground adjustable trim tab. (Ryle)
